Case Report

Frame-Composite Mesh: A New Method to Treat Complex Unstable Flail Chest: A Case Report

J Med Assoc Thai 2010; 93 (1): 123-7 Full text. e-Journal: http://www.mat.or.th/journal

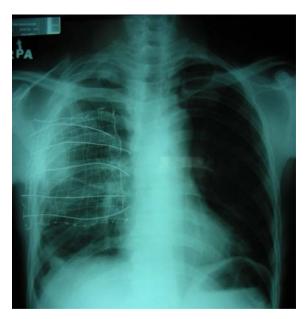
Fig. 6 Chest X-ray taken two weeks after implantation revealed mesh position at right upper chest and resolved of hemothorax

Following the operation, the patient could be disconnected from the mechanical ventilator and extubated the next morning uneventfully. As a result, he was able to be discharged from the hospital after several more days of observation. Two weeks after his discharge (Fig. 6, 7), he was well and had good pulmonary function (FVC 2.63 L (70%), FEV1 2.10 L (67%), FEV1/FVC 83%).
